# Public Health Assessment

**Former Gopher Ordnance Works**

**ROSEMOUNT, DAKOTA COUNTY, MINNESOTA**

**Prepared by  
Minnesota Department of Health**

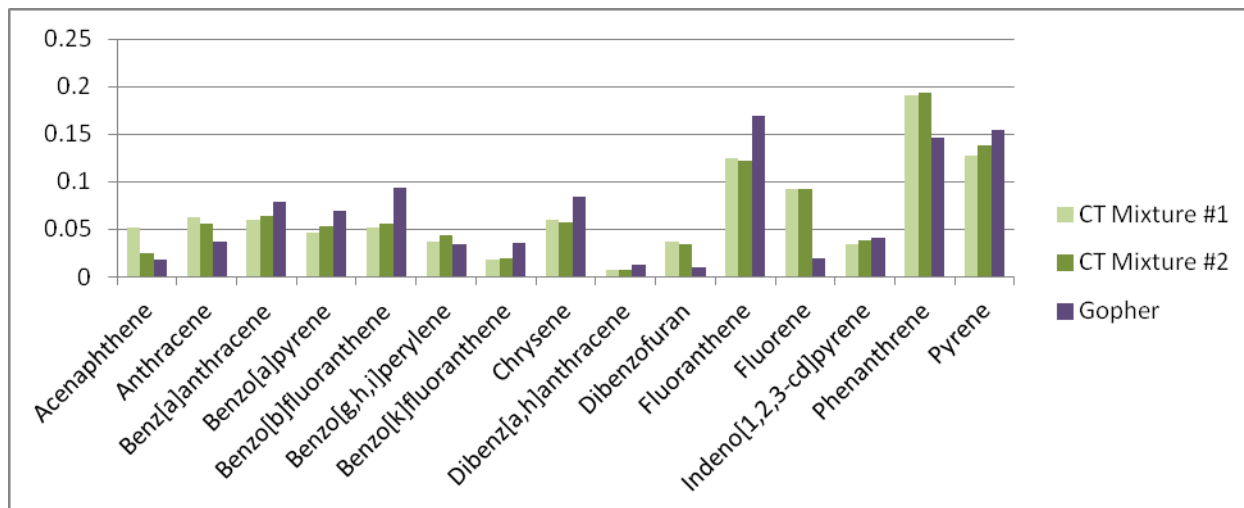
**Chart 1: Fingerprint comparison (15 PAHs) of Coal Tar Mixtures and 10 PAH samples at GOW (see Appendix D for data)**

An analysis of the concentrations of individual cPAHs relative to each other at GOW indicates that PAHs are likely coal-tar based because the ratios of the seven cPAHs correlate well to other known coal-tar based mixtures. In Chart 1, below, 15 PAHs analyzed in GOW soil samples (Barr, 2012; Peer, 2006) are compared with the two mixtures of coal tar that were used in a two-year chronic mouse cancer study (Culp et al., 1998). Table 4 shows the correlation coefficients between the plotted data sets. Note that the correlation between the two coal tar mixtures used by Culp et al. is quite good (0.98), and the correlation between the Culp et al. data and GOW data are not as strong (0.78 – 0.81). The 4-6 ring PAH fractions in the GOW data is greater than the 4-6 ring PAH fraction found in coal tar (Table 4) (fluoranthene, a 3-ring PAH, is also increased). This may suggest that some of the differences between coal tar and the GOW data may be the result of weathering.

CT (Coal Tar) Mixtures from Culp et al. (1998)

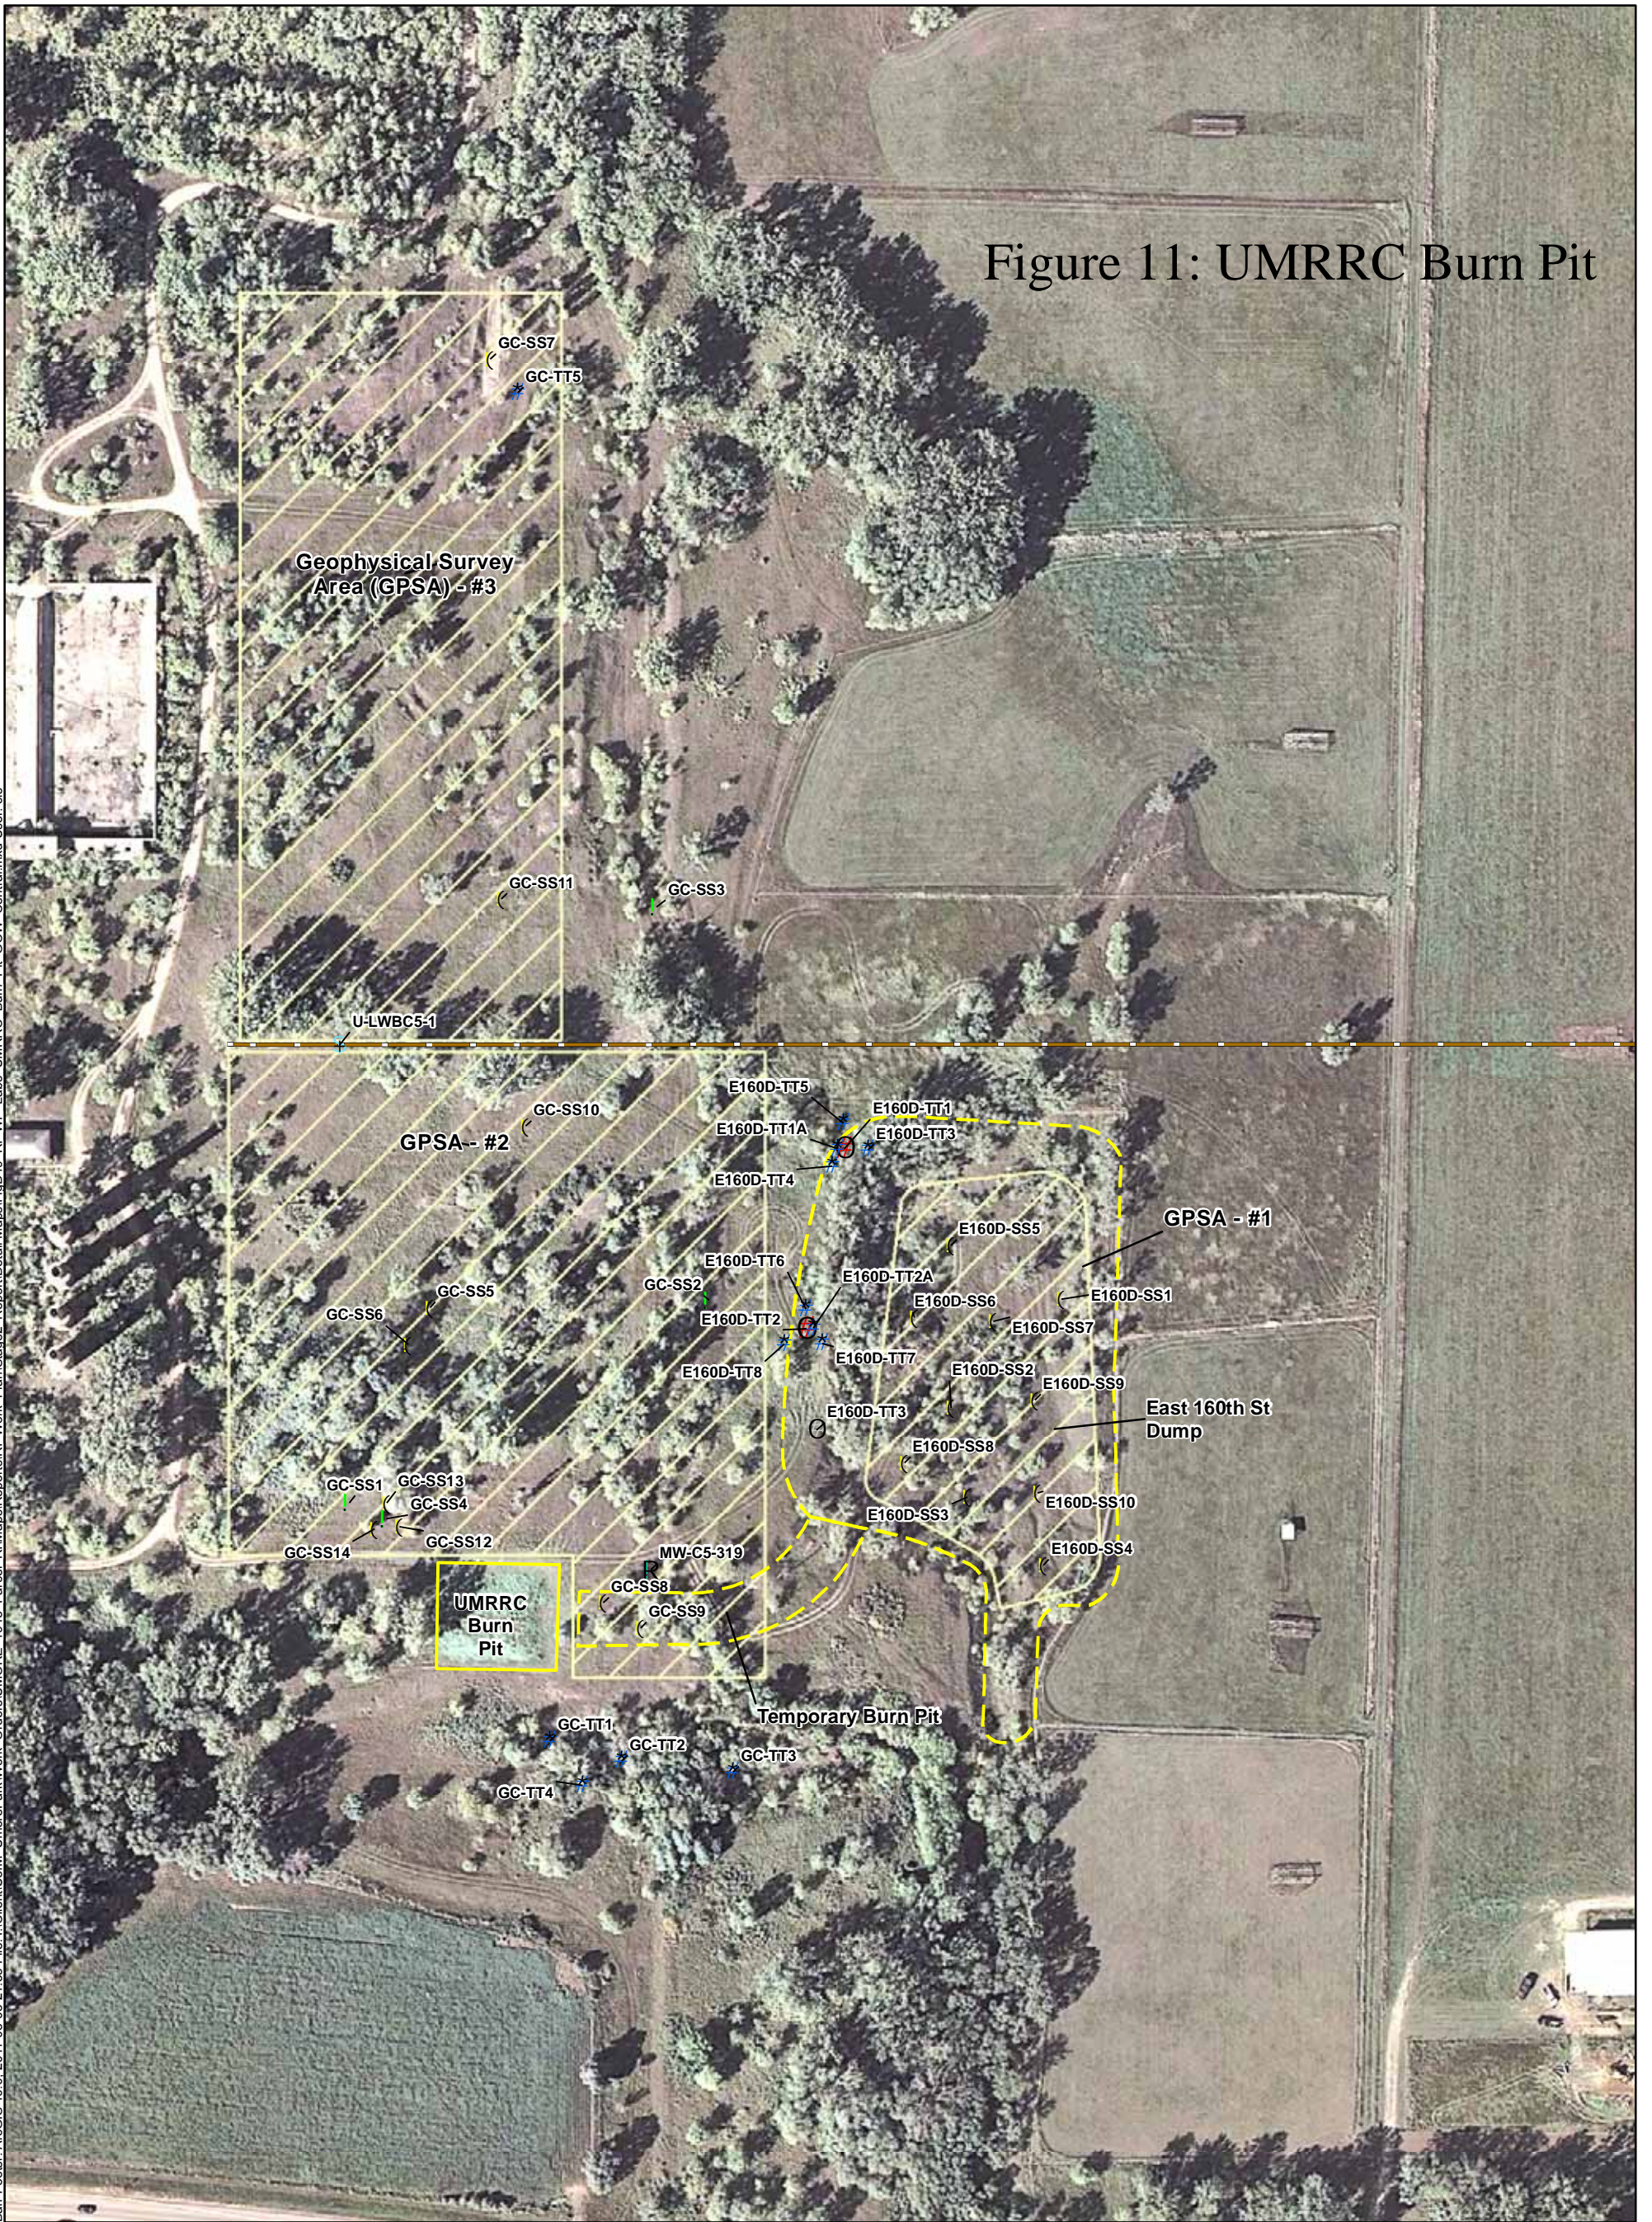
Figure 11: UMRRC Burn Pit

**Pre-RI Sample Locations**

- T Pre-RI Sample Location
- ! Wells and Borings Surveyed by Barr

From 1967 (or possibly earlier) to 1974 the University operated a burn pit for the disposal of chemical waste (Figures 6 and 11). An estimated 90,000 gallons of lab chemicals, solvents, corrosives, salts, heavy metals, organics and inorganics were allowed to soak into the soil or were burned (USEPA, 2007). In 1980, the pit was lined with lime, backfilled with sand, and capped with clay to prevent additional infiltration of rain or meltwater that could help move the contaminants through the soil to the groundwater (USEPA, 2007).

Despite the large volumes of chemicals disposed at the Burn Pit, no soil sampling was reportedly ever conducted there. The depth of the fill material is unknown. Two surface soil samples in a former temporary burn pit east of the University Burn Pit were analyzed for metals and SVOCs in 2011. No evidence of contamination was found (Barr, 2012). As acknowledged in the RI report, significant data gaps exist because of the lack of investigation in this area (Barr, 2012). Additional sampling is needed to understand the contamination in this area. The University Burn Pit area is marked by fence posts, but no fence exists.

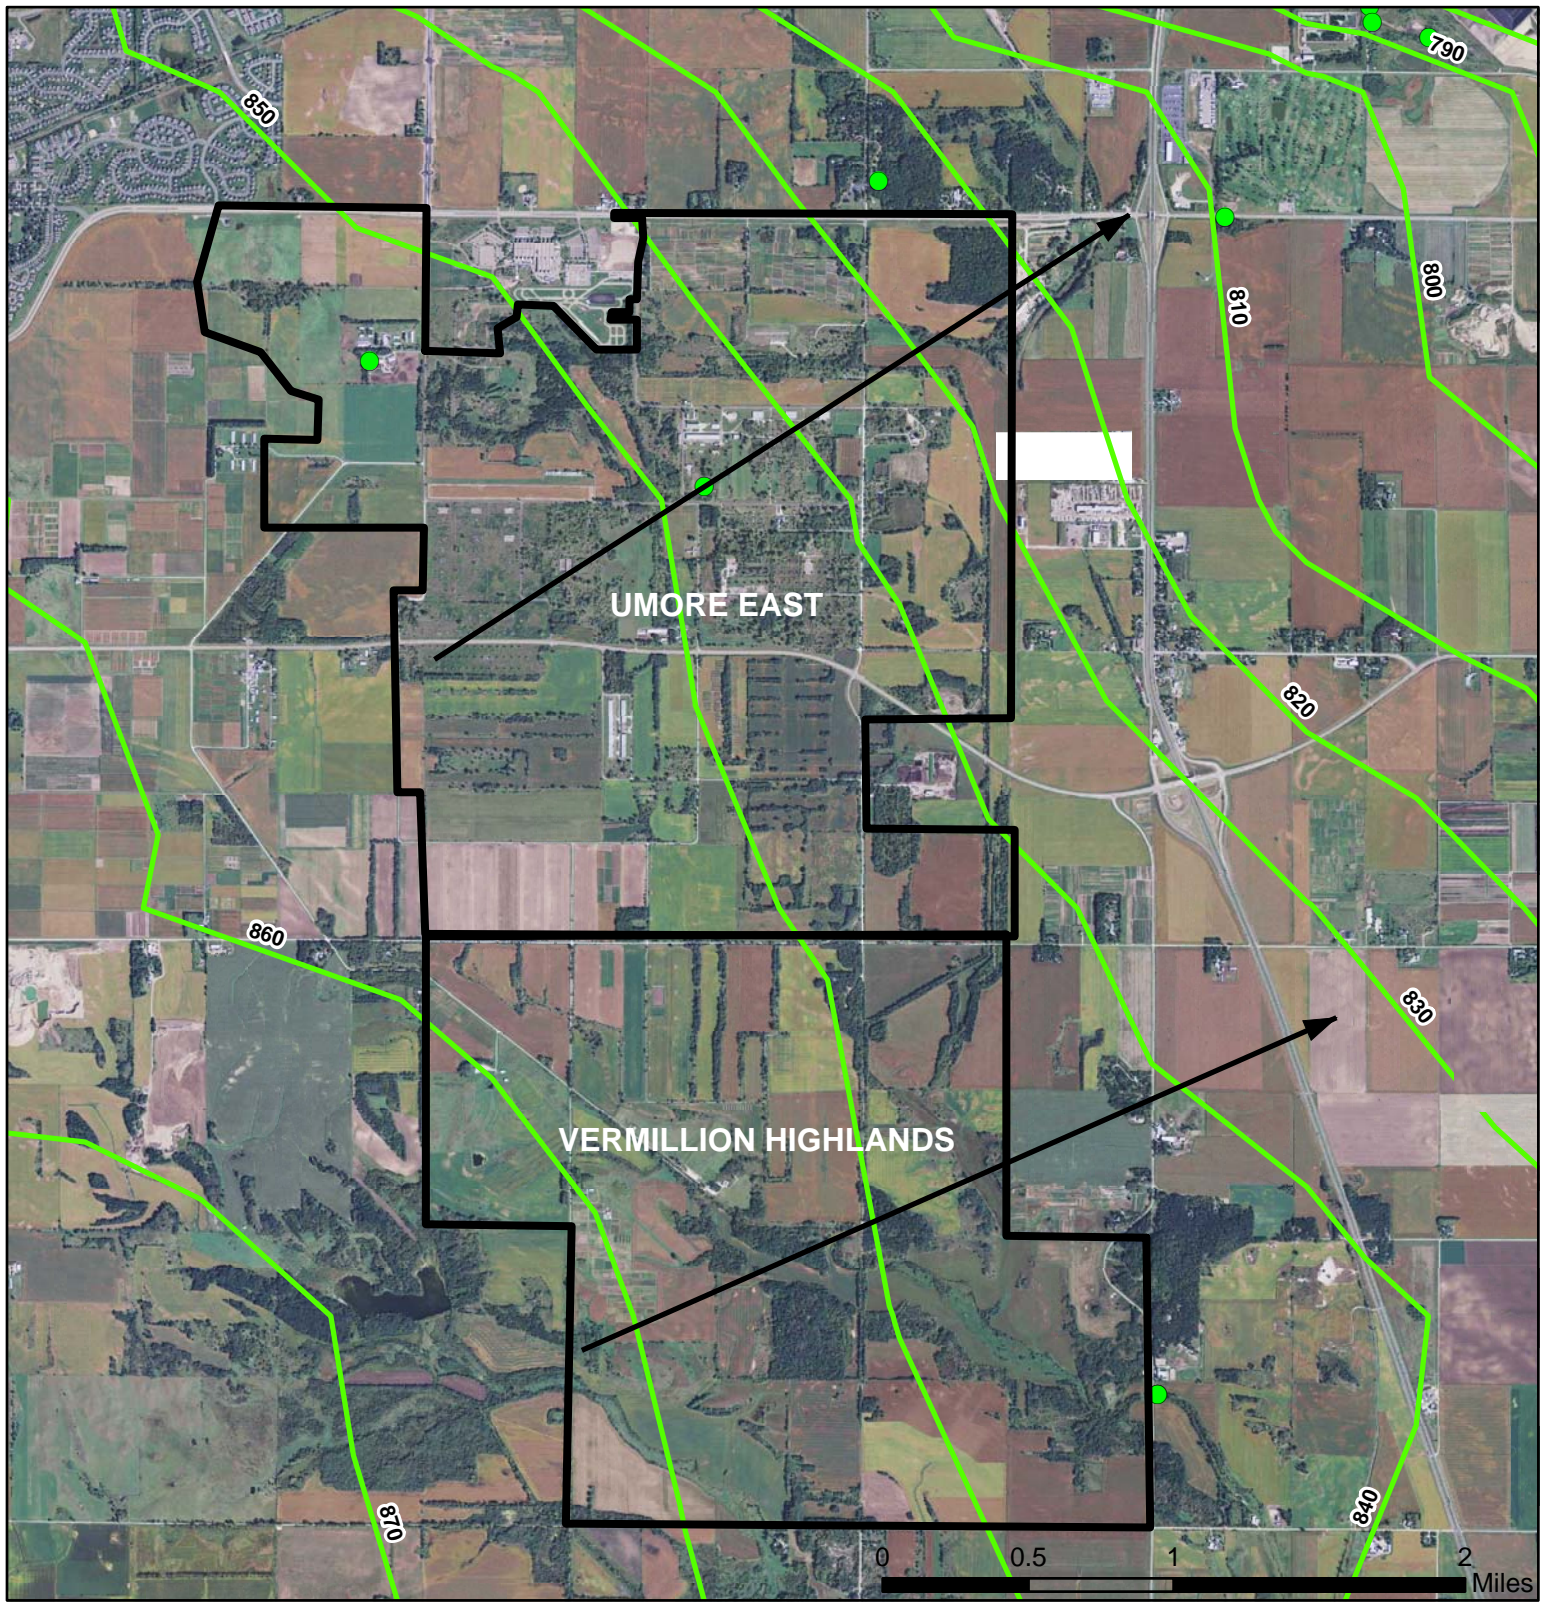
**Figure 18: Flow Directions in Quaternary Aquifer**

Static water level data obtained from Minnesota County Well Index

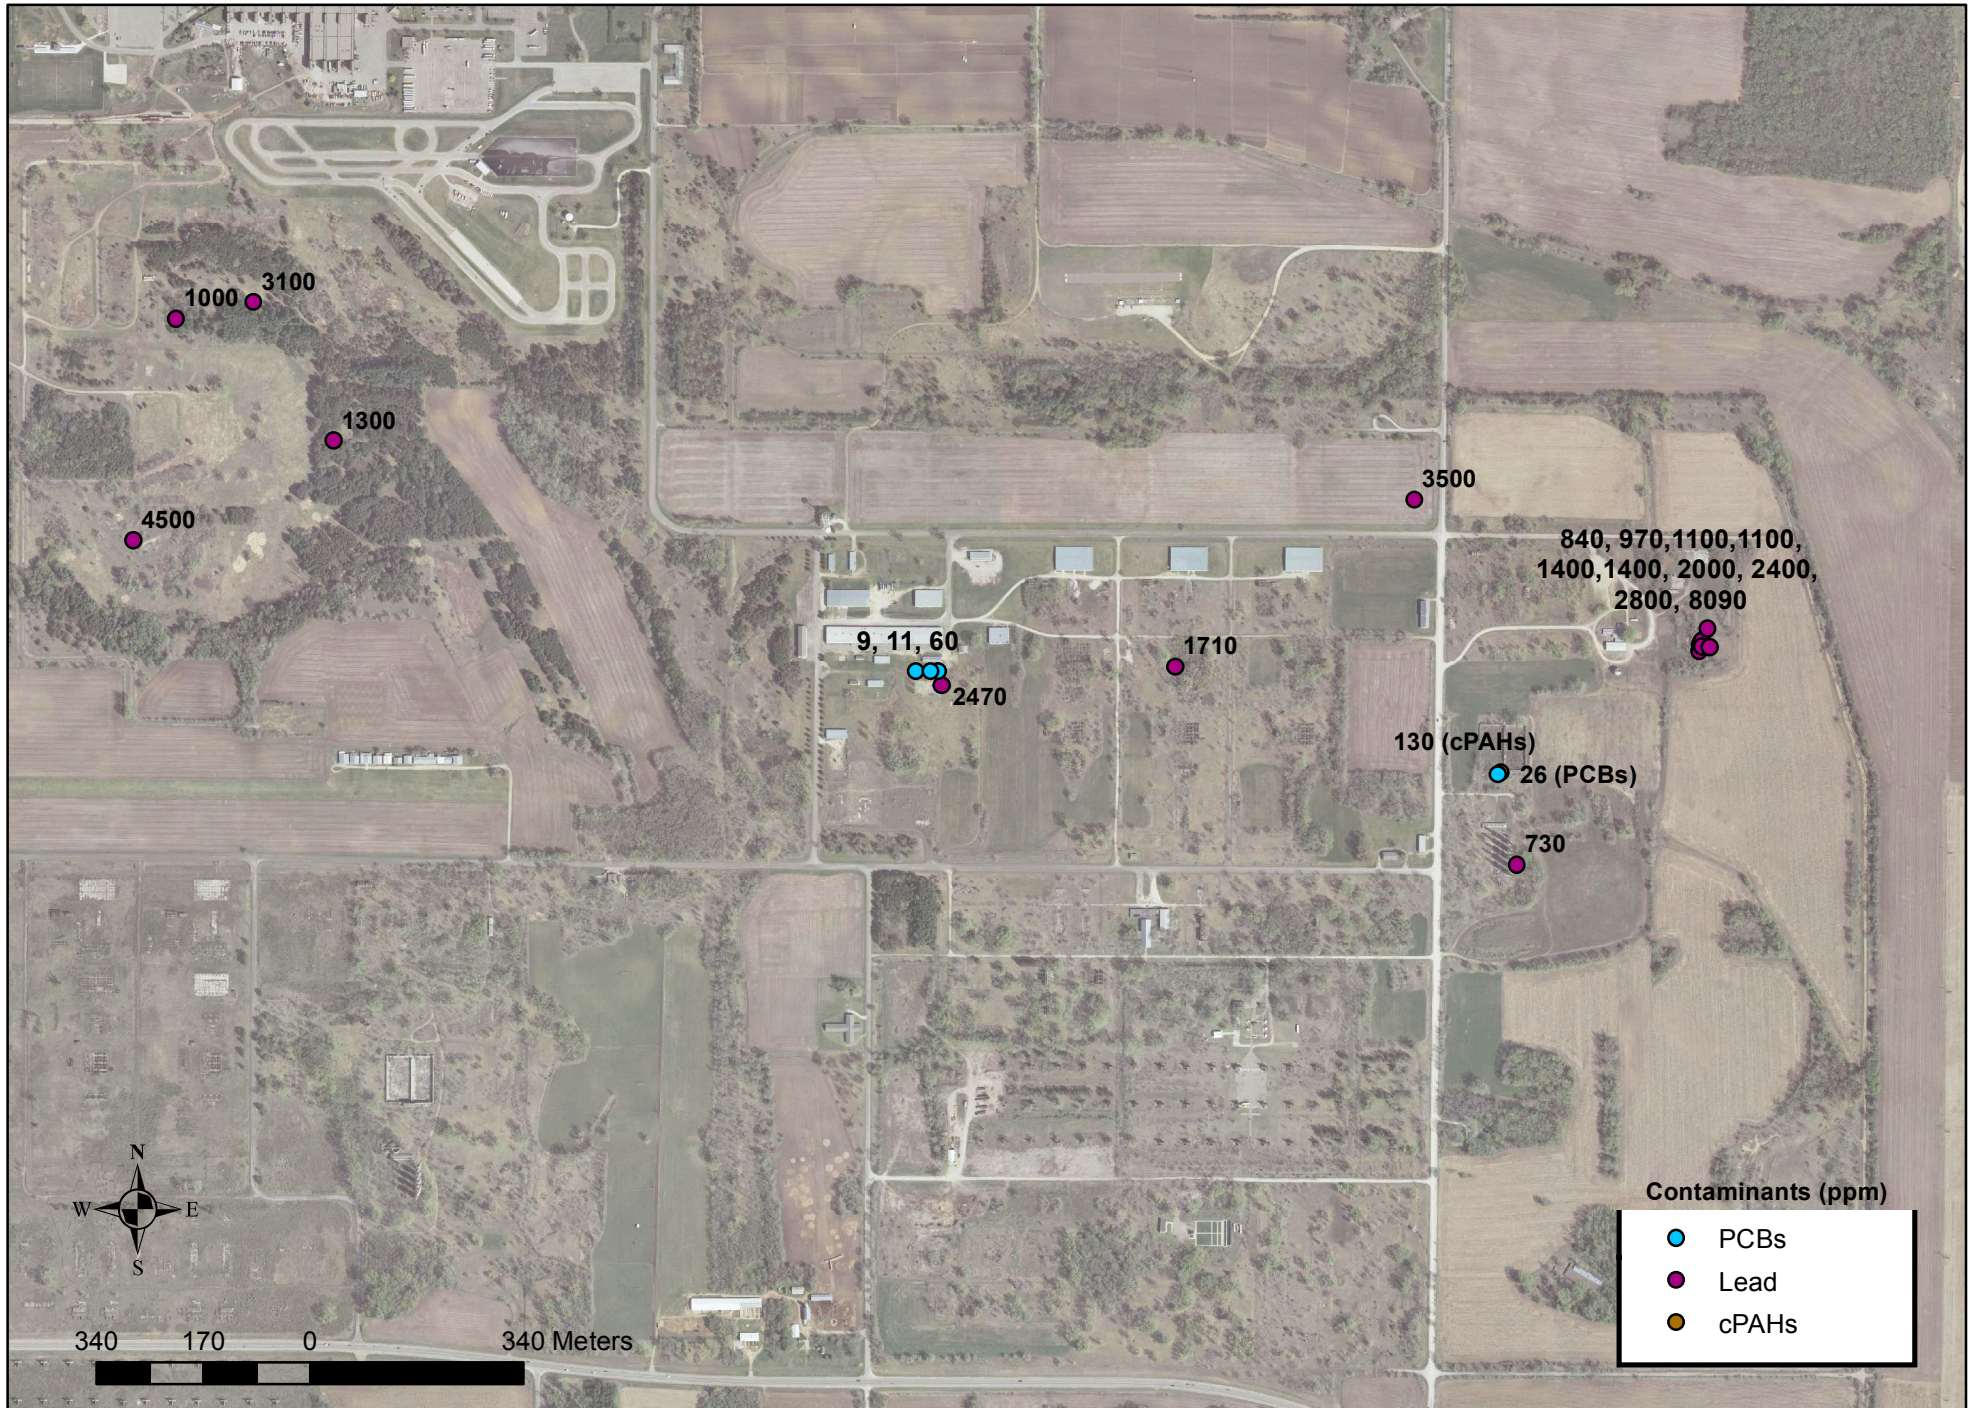
**Figure 24: Highest PCB, lead, and cPAH concentrations in surface soil that are recommended for removal**

A concentration of cPAHs of 260 ppm is located off of the map in the southern portion of the former GOW drainage basin in the Vermillion Highlands.

Recommendations	<ol style="list-style-type: none"> <li>1. Remove and properly dispose of soils in selected areas that exceed the industrial SRVs.</li> <li>2. Notify tenants in affected areas of the contamination in the vicinity of their rented properties.</li> </ol>
CONCLUSION 3	MDH concluded that contaminated soils in some areas of the site pose an indeterminate public health hazard.
Basis for conclusion	<p>Concentrations of site-related contaminants in soils exceed industrial and/or residential SRVs. Contaminants include lead, mercury, arsenic, cPAHs, and PCBs. Asbestos-containing building material debris was found in some areas of the site.</p> <p>Current exposure is expected to be limited in frequency and duration, but future land uses may result in greater exposures.</p>
Recommendations	Asbestos containing building materials should be removed from the site. Soils with contaminants exceeding the industrial and/or residential SRVs may need to be removed and properly disposed of if future land use changes. Additional investigation may be needed in order to determine what actions are required.
